RESEARCH MEMORANDUM

PRELIMINARY INVESTIGATION OF SEVERAL ROOT DESIGNS FOR

CERMET TURBINE BLADES IN TURBOJET ENGINE

II - ROOT DESIGN ALTERATIONS

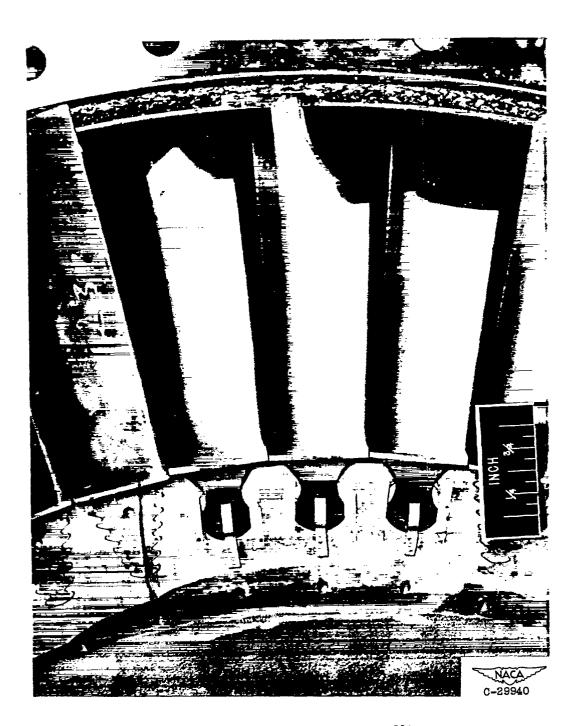
Run 11A. - Because the apparent damage to the other cermet blades in run 11 was very slight, and after penetrant-oil inspection indicated that these blades were still sound, the failed blade was replaced and the wheel was rebalanced. This assembly did not attain rated speed but failure occurred in the airfoil during acceleration at 50 rpm below rated speed. Possibly the failure resulted from a defect in the previously used blades which was not detected during inspection. The broken cermet airfoils are shown in figure 3.

Figure 3. - Airfoil failures in run 114.

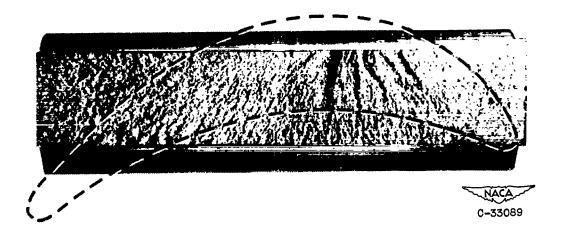
As mentioned earlier, the root failures occurred consistently adjacent to the metal blades. Examination of interlock root failures showed that all the fractures seemed to originate in exactly the same area, near the center of the root length and on the side of the root cross section corresponding to the suction or convex side of the airfoil (figs. 1, 4, and 5). These facts suggested that load distribution in the root was unfavorable and that the blade should be redesigned to improve this condition. Up to this point all airfoils were located on the platforms in precisely the same manner as were the metal blades in the standard engine, and the root center lines were parallel to the turbine axis.

If the profile of the airfoil at its base is superimposed on the photograph of a fractured root surface (fig. 8), it becomes apparent that the failure invariably starts at the location of the largest concentration of mass of the airfoil. The presence of bending stresses in the root neck is evident because the failure generally starts at the

Figure 8. - Airfoil profile superimposed on failure surface.

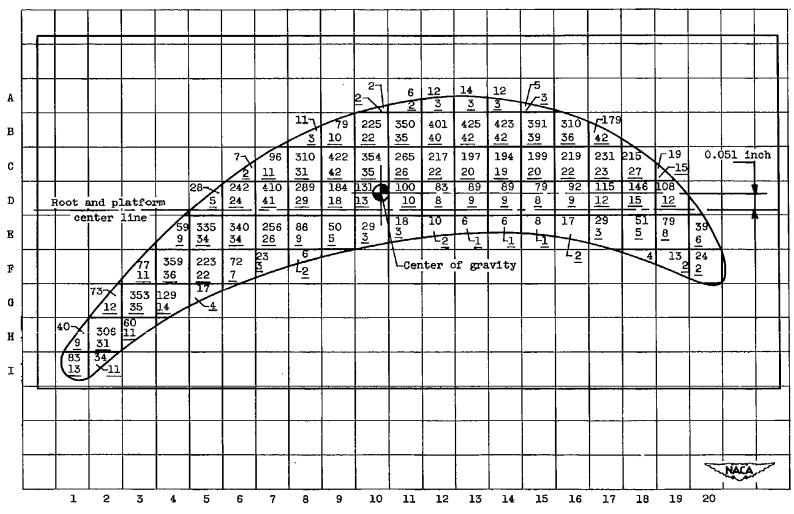
Results of calculation. - The results of the calculations are shown in figure 10. The upper numbers in each square are the total centrifugal forces in pounds acting on each square and the lower numbers (underscored) are the stresses (in 1000-psi units) that would be acting on the base plane squares if each column were cut free from its neighbors. Actually, there would be a gradual variation in stress from one square to the next. From the magnitude of the numbers presented and their location, it is obvious that the greatest centrifugal loads and stresses are in the region where most of the failures originated. The location of the radial projection of the center of gravity of the whole airfoil is determined by dividing the summation of moments of the centrifugal force of the individual columns times their distance from an arbitrary axis by the summation of the centrifugal forces.

Effect of offset center of gravity. - The procedure described shows the projection of the center of gravity on the base plane to be displaced 0.051 inch in the direction of rotation from the center line of the blade platform and root. This offset introduces a sizable bending moment in the blade root which is only partly compensated for by the gas forces on the airfoil. The gas force per blade as determined in the appendix of this report is 100 pounds at rated speed and

Figure 10. - Centrifugal force and stress distribution at base cross-section of airfoil.

The bending stress resulting from this computation is ±6990 pounds per square inch. If then the airfoil is shifted 328 divided by 11,300, or 0.029 inch, in the tangential direction toward the concaved or pressure side of the blade, this bending stress can be virtually eliminated.

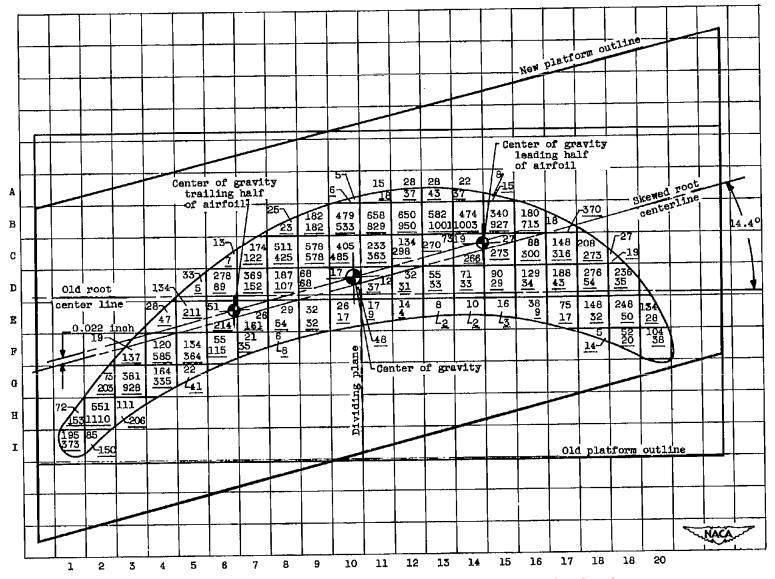
Determination of skewing angle. - The skewing angle was established by finding the centers of gravity of the leading and trailing halves of the airfoil. Assume that the blade is cut lengthwise by a dividing plane through the midchord points and perpendicular to the turbine axis. Then the radial projection of the centers of gravity of each half on the base plane can be readily calculated from the previous computations, and a line drawn through these centers was used to determine the skewing angle, which in this case is 14.4° (see fig. 11).

The root center line should be offset from the line thus established sufficiently (0.022 inch in this case) to compensate for the bending moment caused by the gas force. In figure 11, the numbers within the airfoil are the products of the centrifugal force of the long thin individual columns used earlier and their distance from the old (parallel to turbine axis) and new (skewed) center lines of the platform and root. The lower numbers (underlined) in each square are for the old center line and the upper numbers correspond to the skewed center line. The exact values of these numbers are not a direct measure of the actual stress distribution in the root, but the relative magnitudes of the numbers are indicative of the amount of overhang or the stress magnitude in corresponding areas in the root.

Effect of skewed root. - The largest number with the old center line is 1110, square 2-H, which might intimate that failure should have started in the root below the trailing edge. However, surrounding values are considerably less and thus would tend to reduce the peak stress at this location. The second largest number with the old center line is 1007, square 13-B, and is flanked by similar high values and therefore would be expected to influence the point where the root failures originated. The actual failure did start in this area.

The largest number with respect to the new center line is 658 (square 11-B), or appreciably less than the largest with the old axis. The 1110 value is reduced to 551, or by about one half. The 1007 value is also about halved, or is 582. The values in the vicinity of the leading edge are multiplied four or five times, but the values are still relatively low because the leading edge of the airfoil is swept back rapidly as the distance from the turbine axis increases. Consequently, skewing the blade root with respect to the airfoil and turbine axis should prove very beneficial.

Figure 11. - Relative bending moment comparison for standard and skewed roots.

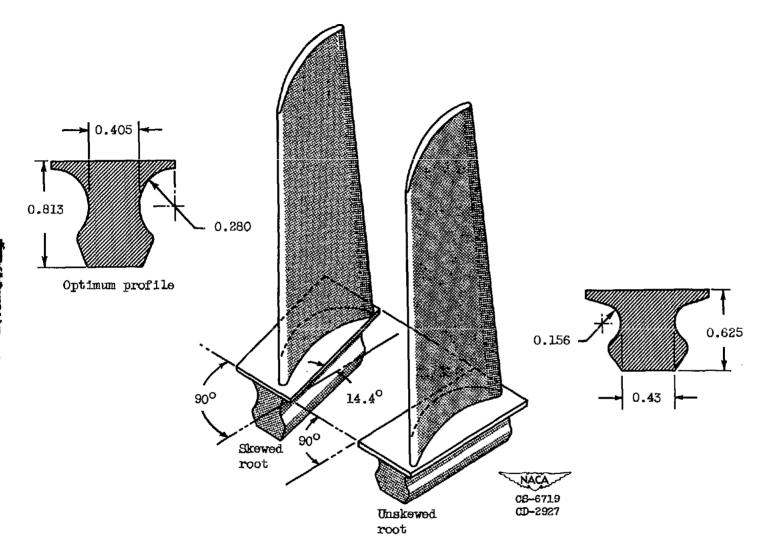
The results of a separate investigation on root profile design are reported in reference 2. In this reference optimum root proportions were determined to give maximum strength in pure tension. The experimental failure load for the small-radius dovetail profile is 37,190 pounds. When the optimum proportions of reference 2 are used, the same load is 41,220 pounds, or an improvement of 11 percent, as established by tensile tests of cermet specimens at 1200° F, reference 4. The increase was caused by a decreased stress concentration factor resulting from increasing the notch radius in the root from 0.156 inch to 0.280 inch. The neck distance in the root had to be reduced from 0.438 inch to 0.405 inch to accommodate the larger-radius root; nevertheless, it is stronger as a result of the lower stress concentration factor. The new root including both the skewing and the new profile is sketched along with the earlier dovetail for comparison in figure 12.

Figure 12. - Dimensions of standard and skewed dovetail cermet blades. (All dimensions are in inches.)

- 1. The root was displaced with respect to the airfoil to reduce bending stresses.
- 2. The root and platform were skewed 14.40 to reduce the overhang at the trailing edge and at midchord position on the convex side of the blade.
 - 3. The optimum root profile proportions were used.
 - 4. The blades were made from refined quality material.
- 5. Two blades were inserted in the space originally occupied by three blades; thus reducing the bending effect of the heavier metal blades in adjacent slots.

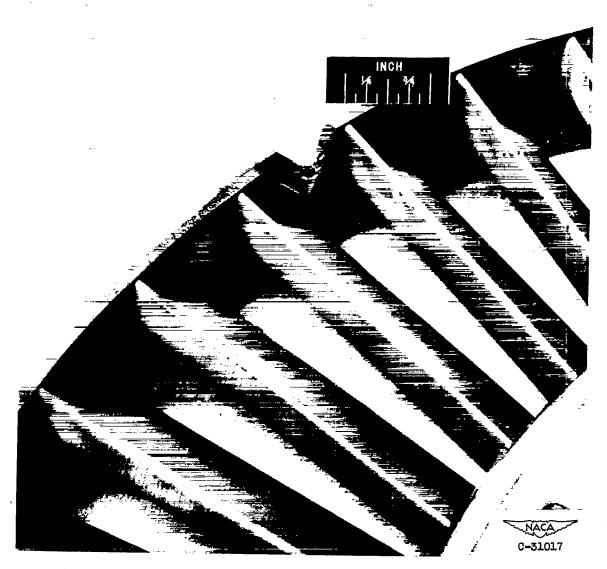
Run 14. - The engine with the new blades ran 112.5 hours before disassembly for over-all inspection. Run 14 and all previous runs with cermets were run with slightly opened tail cone because other engine parts cannot withstand continuous operation at rated power and speed, 11,750 rpm. Rotational speed and not power is the most important criterion determining the life of cermet blades. However, to include any additional effects that may be precluded by the limited power operation, the same four cermet blades were next operated at full power for 17 hours, at which time the nozzle diaphragm shroud failed and broke the cermet airfoils (fig. 13), completing run 14 of table I. Figure 14 shows the missing piece of the shroud band which passed through the turbine. The tail cone assembly had to be replaced frequently during the full-power operation and also the combustion-chamber tube assembly was excessively cracked.

Figure 14. - Nozzle diaphragm failure which caused airfoil failures; run 14.

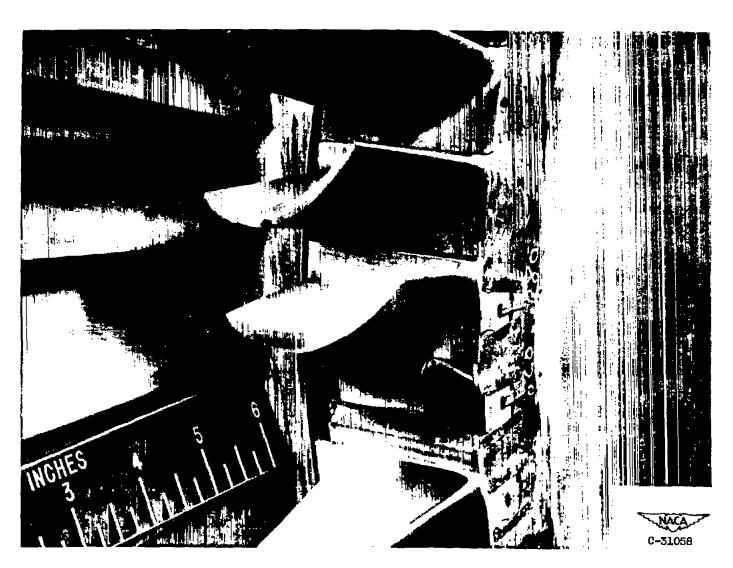
Figure 16. - Failure of interlock root made from refined material; run 16.

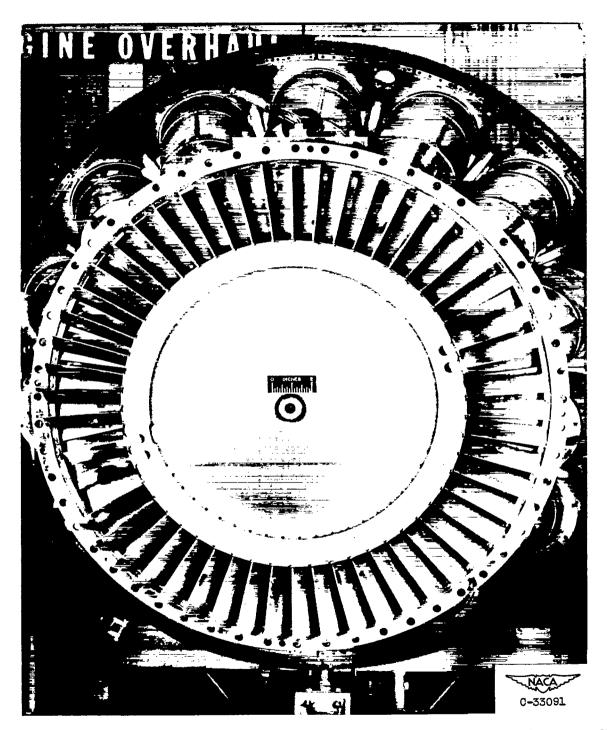
Run 17. - To evaluate the foregoing hypothesis concerning notch radii differences, four skewed-root blades were inserted in a new turbine wheel, two of the large-radius profile on one side of the wheel and two of the small-radius profile on the diametrically opposite side. The intention in run 17 was to run the engine 50 hours at rated speed and power (closed tail cone) and then proceed with cyclic operation. The engine ran 36 hours before the blades were damaged (fig. 17)

as a result of fatigued fragments breaking loose from the combustion domes and liners and passing through the turbine. Even though no cyclic operation was obtained to evaluate the effect of thermal expansion and contraction on the different radii, sufficient operating time was obtained at full power to indicate that probably the displacing and skewing of the root, and not the change in profile, were the primary factors leading to increased blade life.

Figure 17. - Failure of airfoils resulting from fatigue of combustion domes and liners; run 17.
